**SAMPLE PROPERTY OWNERS
ASSOCIATION
CITY, STATE**

**FULL RESERVE
STUDY**

GILES & FLYTHE
ENGINEERS

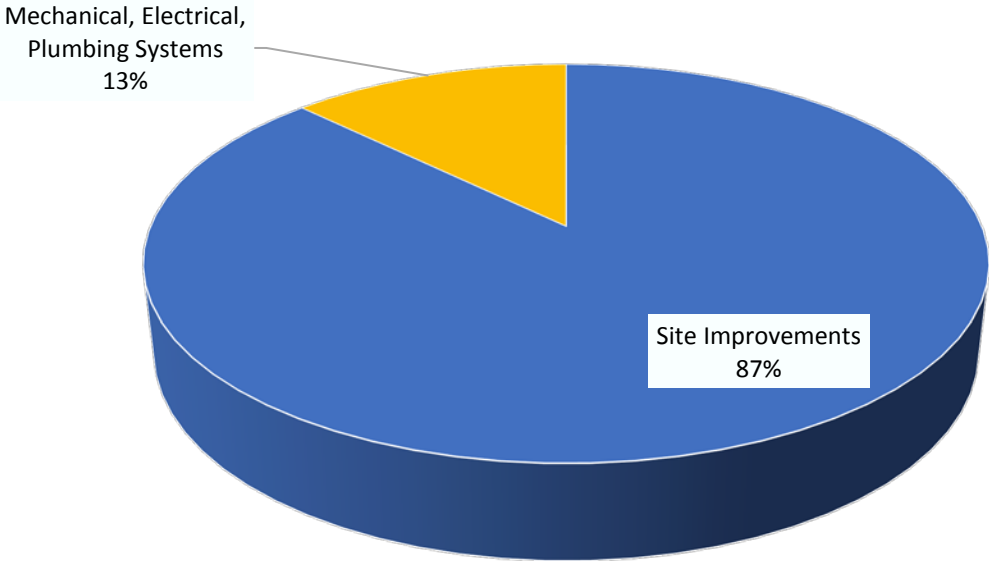
Breakdown of Total Costs by Type

Total over term capital expenditure (un-inflated)	\$1,108,813
Total over term capital expenditure with inflation:	\$1,477,283
Average estimated annual capital expenditure with inflation:	\$73,864
Current Reserve Account Balance	\$241,187
Full Funding Balance	\$204,453
Percent Funded	117.97%

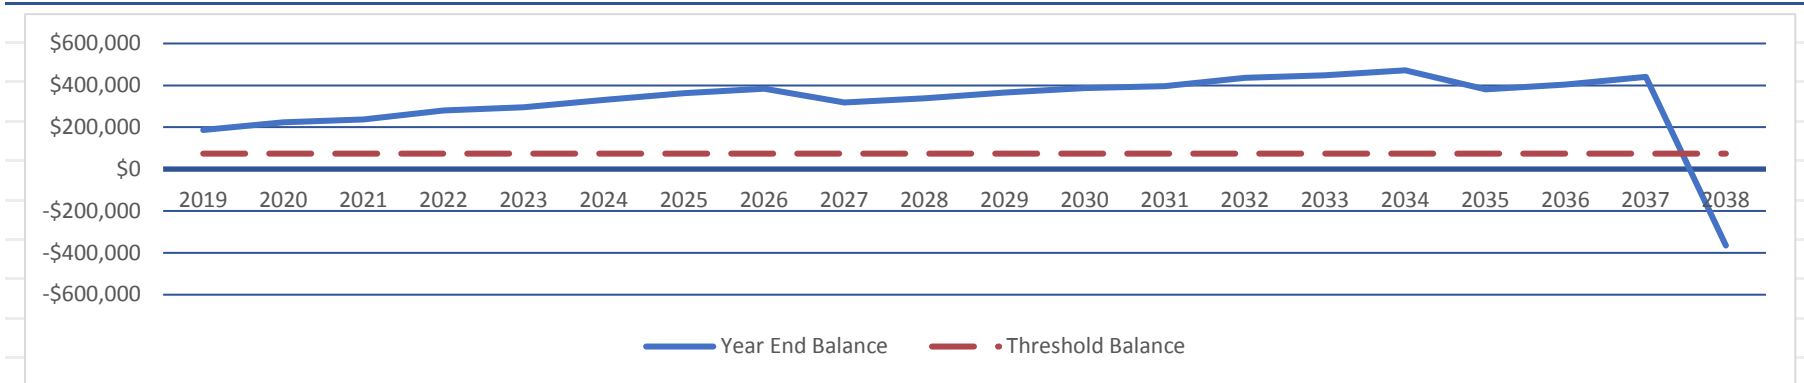
Current Funding Analysis

Year	Starting Balance	Reserve Account Contribution	Average Per Unit/Month	Return on Investments	Repair Expenses	Special Assessments	Year End Balance
2019	\$241,187	\$40,083	\$36.71	\$2,412	\$97,588	\$0	\$186,094
2020	\$186,094	\$40,083	\$36.71	\$1,861	\$4,590	\$0	\$223,448
2021	\$223,448	\$40,083	\$36.71	\$2,234	\$28,481	\$0	\$237,285
2022	\$237,285	\$40,083	\$36.71	\$2,373	\$0	\$0	\$279,741
2023	\$279,741	\$40,083	\$36.71	\$2,797	\$27,061	\$0	\$295,560
2024	\$295,560	\$40,083	\$36.71	\$2,956	\$8,612	\$0	\$329,987
2025	\$329,987	\$40,083	\$36.71	\$3,300	\$11,262	\$0	\$362,108
2026	\$362,108	\$40,083	\$36.71	\$3,621	\$21,681	\$0	\$384,131
2027	\$384,131	\$40,083	\$36.71	\$3,841	\$110,239	\$0	\$317,817
2028	\$317,817	\$40,083	\$36.71	\$3,178	\$23,304	\$0	\$337,774
2029	\$337,774	\$40,083	\$36.71	\$3,378	\$16,213	\$0	\$365,022
2030	\$365,022	\$40,083	\$36.71	\$3,650	\$21,137	\$0	\$387,618
2031	\$387,618	\$40,083	\$36.71	\$3,876	\$34,718	\$0	\$396,859

2032	\$396,859	\$40,083	\$36.71	\$3,969	\$4,528	\$0	\$436,383
2033	\$436,383	\$40,083	\$36.71	\$4,364	\$32,987	\$0	\$447,842
2034	\$447,842	\$40,083	\$36.71	\$4,478	\$20,592	\$0	\$471,812
2035	\$471,812	\$40,083	\$36.71	\$4,718	\$135,340	\$0	\$381,274
2036	\$381,274	\$40,083	\$36.71	\$3,813	\$20,829	\$0	\$404,341
2037	\$404,341	\$40,083	\$36.71	\$4,043	\$7,855	\$0	\$440,612
2038	\$440,612	\$40,083	\$36.71	\$4,406	\$850,268	\$0	-\$365,167

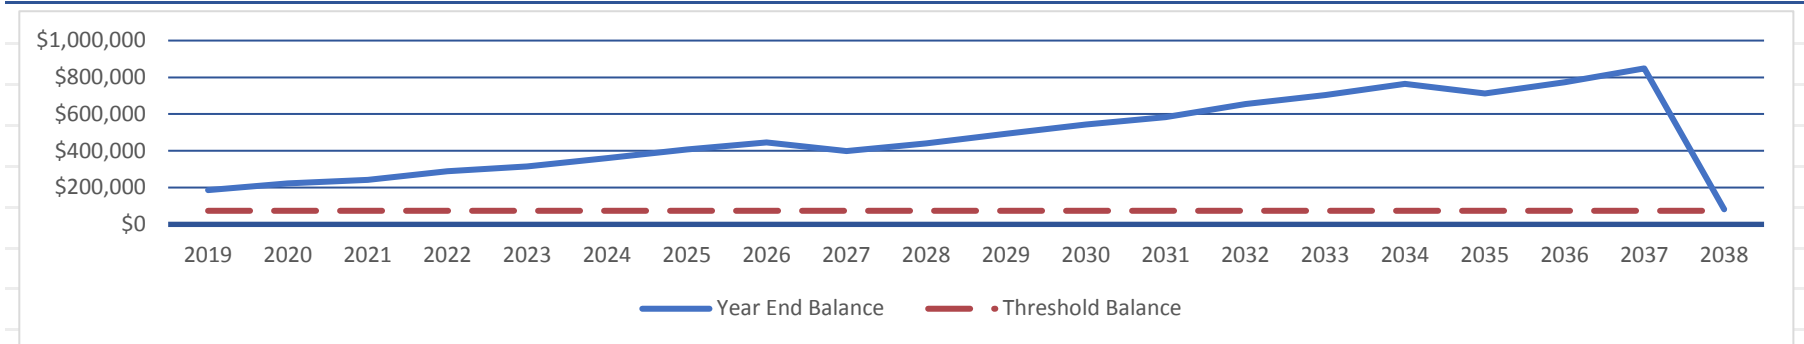
Funding Alternative 1

Year	Starting Balance	Reserve Account Contribution	Average Per Unit/Month	Return on Investments	Repair Expenses	Special Assessments	Year End Balance
2019	\$241,187	\$40,083	\$36.71	\$2,412	\$97,588	\$0	\$186,094
2020	\$186,094	\$40,083	\$36.71	\$1,861	\$4,590	\$0	\$223,448
2021	\$223,448	\$45,083	\$41.28	\$2,234	\$28,481	\$0	\$242,285
2022	\$242,285	\$45,083	\$41.28	\$2,423	\$0	\$0	\$289,791
2023	\$289,791	\$50,083	\$45.86	\$2,898	\$27,061	\$0	\$315,711
2024	\$315,711	\$50,083	\$45.86	\$3,157	\$8,612	\$0	\$360,339
2025	\$360,339	\$55,083	\$50.44	\$3,603	\$11,262	\$0	\$407,764
2026	\$407,764	\$55,083	\$50.44	\$4,078	\$21,681	\$0	\$445,243
2027	\$445,243	\$60,083	\$55.02	\$4,452	\$110,239	\$0	\$399,540
2028	\$399,540	\$60,083	\$55.02	\$3,995	\$23,304	\$0	\$440,314
2029	\$440,314	\$65,083	\$59.60	\$4,403	\$16,213	\$0	\$493,588
2030	\$493,588	\$65,083	\$59.60	\$4,936	\$21,137	\$0	\$542,469
2031	\$542,469	\$70,083	\$64.18	\$5,425	\$34,718	\$0	\$583,259

2032	\$583,259	\$70,083	\$64.18	\$5,833	\$4,528	\$0	\$654,647
2033	\$654,647	\$75,083	\$68.76	\$6,546	\$32,987	\$0	\$703,289
2034	\$703,289	\$75,083	\$68.76	\$7,033	\$20,592	\$0	\$764,813
2035	\$764,813	\$75,083	\$68.76	\$7,648	\$135,340	\$0	\$712,205
2036	\$712,205	\$75,083	\$68.76	\$7,122	\$20,829	\$0	\$773,581
2037	\$773,581	\$75,083	\$68.76	\$7,736	\$7,855	\$0	\$848,545
2038	\$848,545	\$75,083	\$68.76	\$8,485	\$850,268	\$0	\$81,845

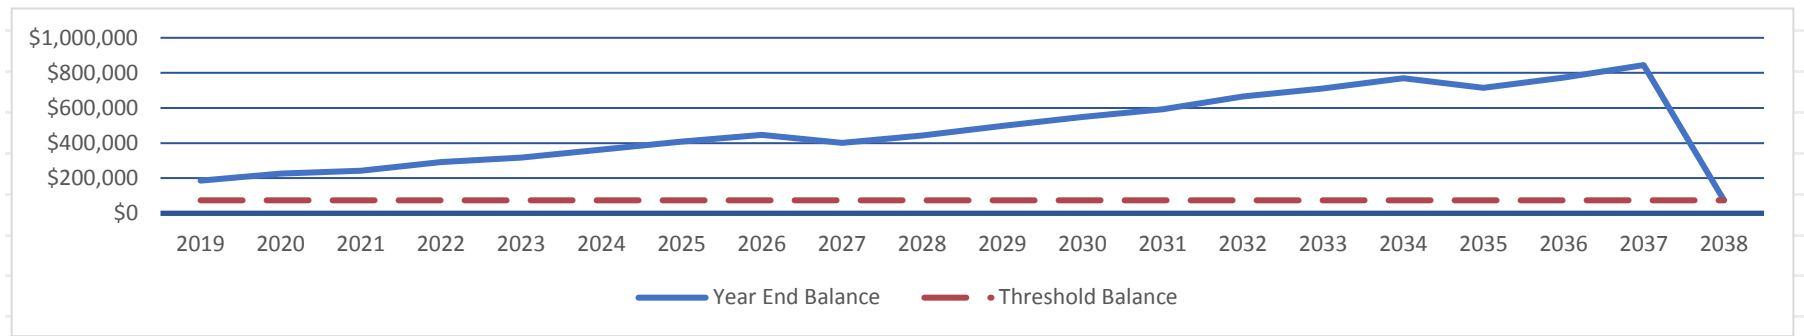
Funding Alternative 2

Year	Starting Balance	Reserve Account Contribution	Average Per Unit/Month	Return on Investments	Repair Expenses	Special Assessments	Year End Balance
2019	\$241,187	\$40,083	\$36.71	\$2,412	\$97,588	\$0	\$186,094
2020	\$186,094	\$42,087	\$38.54	\$1,861	\$4,590	\$0	\$225,452
2021	\$225,452	\$44,192	\$40.47	\$2,255	\$28,481	\$0	\$243,418
2022	\$243,418	\$46,401	\$42.49	\$2,434	\$0	\$0	\$292,253
2023	\$292,253	\$48,721	\$44.62	\$2,923	\$27,061	\$0	\$316,836
2024	\$316,836	\$51,157	\$46.85	\$3,168	\$8,612	\$0	\$362,549
2025	\$362,549	\$53,715	\$49.19	\$3,625	\$11,262	\$0	\$408,628
2026	\$408,628	\$56,401	\$51.65	\$4,086	\$21,681	\$0	\$447,434
2027	\$447,434	\$59,221	\$54.23	\$4,474	\$110,239	\$0	\$400,891
2028	\$400,891	\$62,182	\$56.94	\$4,009	\$23,304	\$0	\$443,777
2029	\$443,777	\$65,291	\$59.79	\$4,438	\$16,213	\$0	\$497,293
2030	\$497,293	\$68,556	\$62.78	\$4,973	\$21,137	\$0	\$549,684
2031	\$549,684	\$71,983	\$65.92	\$5,497	\$34,718	\$0	\$592,446

2032	\$592,446	\$71,983	\$65.92	\$5,924	\$4,528	\$0	\$665,827
2033	\$665,827	\$71,983	\$65.92	\$6,658	\$32,987	\$0	\$711,481
2034	\$711,481	\$71,983	\$65.92	\$7,115	\$20,592	\$0	\$769,987
2035	\$769,987	\$71,983	\$65.92	\$7,700	\$135,340	\$0	\$714,331
2036	\$714,331	\$71,983	\$65.92	\$7,143	\$20,829	\$0	\$772,629
2037	\$772,629	\$71,983	\$65.92	\$7,726	\$7,855	\$0	\$844,483
2038	\$844,483	\$71,983	\$65.92	\$8,445	\$850,268	\$0	\$74,644
